## COMMENTS ON GROUNDWATER DISCHARGE PERMIT

By Charles Judd – October 26, 2009

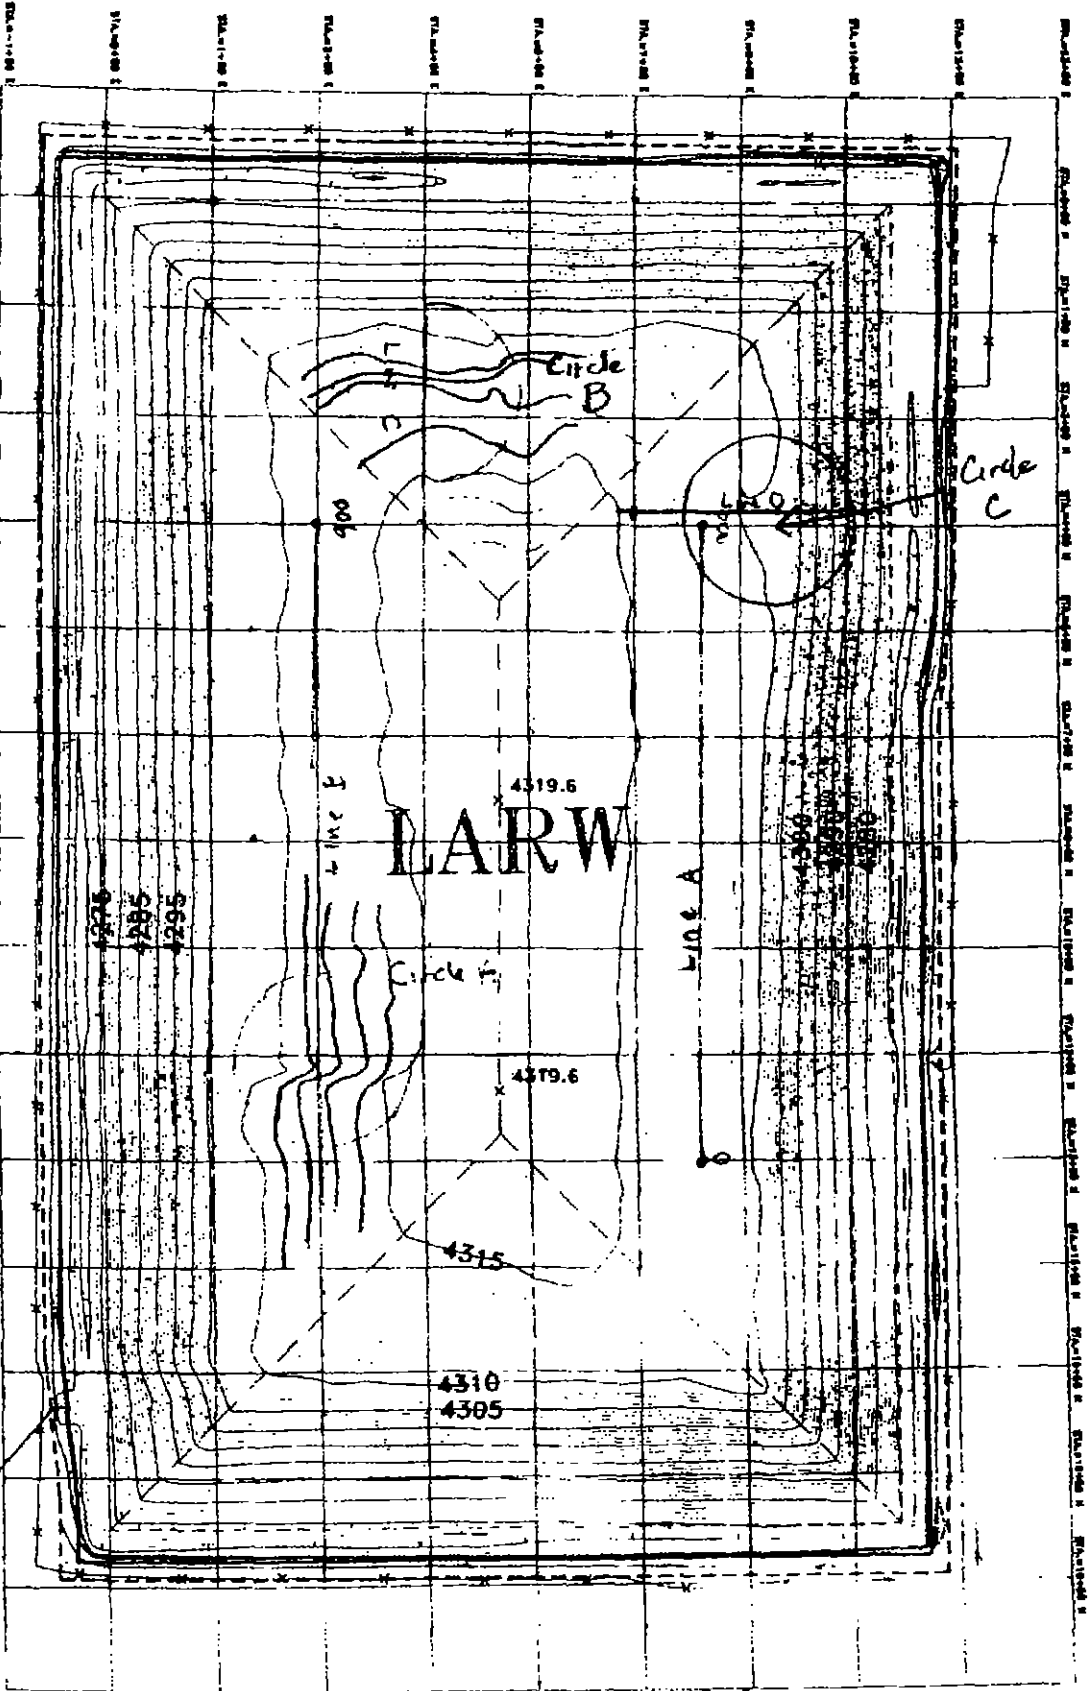
Attachment 7-1 is a map of the completed LARW cell at Clive. The map shows the contour lines as of the end of 2006. There are at least three areas of concern that can be seen just by looking at the contours. The problem areas are shown as Area A, B, and C. Attachment 7-2 shows a cross section of the cover system as it would have been constructed with the old design. The design allows for easy flow of water off of the embankment. Attachment 7-3 shows a cross section of Area C as it was at the end of 2006. In this area there is a section of the embankment that has shown slope reversal. The portion near the edge of the embankment is actually higher than a section of the embankment closer to the middle of the cell. The cross section shows the expected affect of this settlement on the layers of the cover below the rock erosion barrier. As the cover is now constructed the water that is collected in the filter zone begins to run toward the edge of the embankment. Instead of flowing off of the side of the embankment the water will pond and then increase the water infiltration into the radon barrier and also into the waste. The calculations of the amount of infiltration into the embankment do not account for the ponding of water on the top of the embankment.

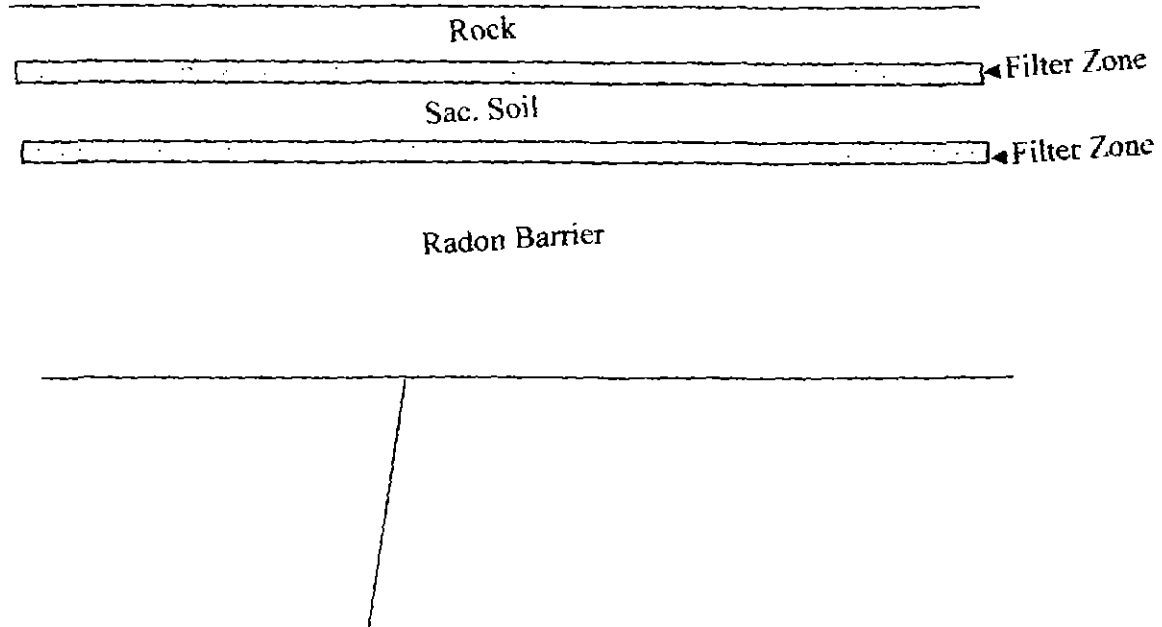
## Attachment 7-2

### LARW Cover Design

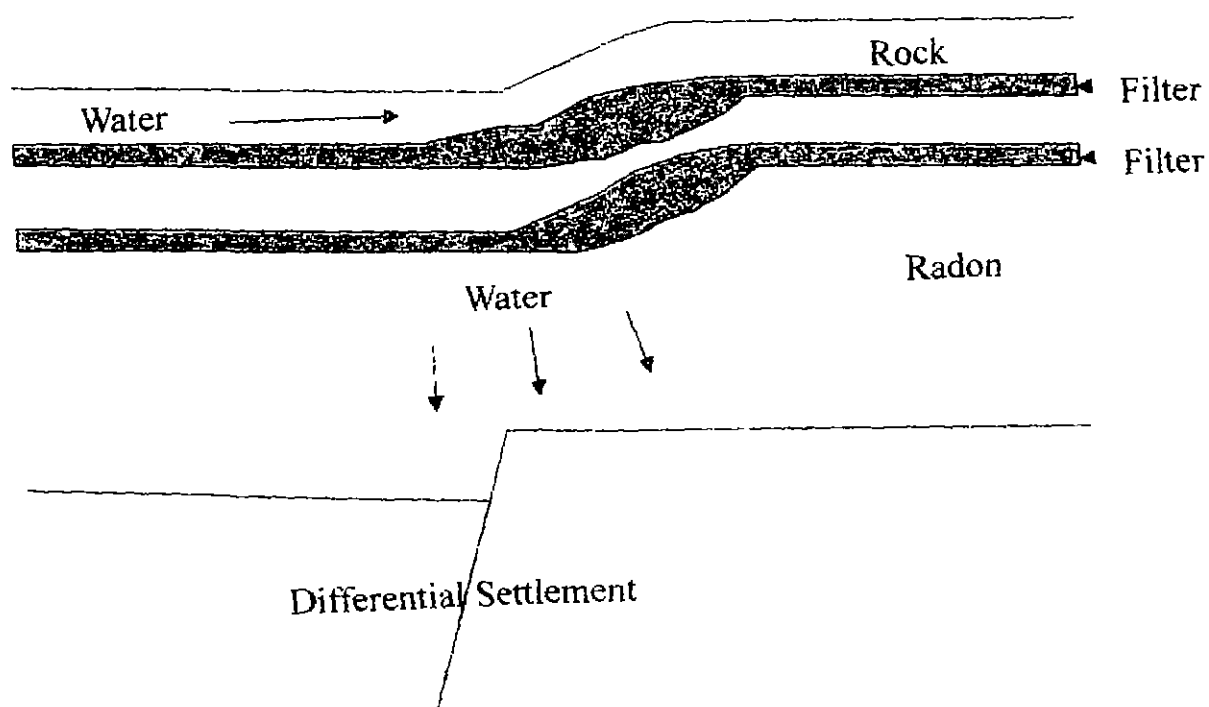
Attachment 7-3

Area C as of 2006

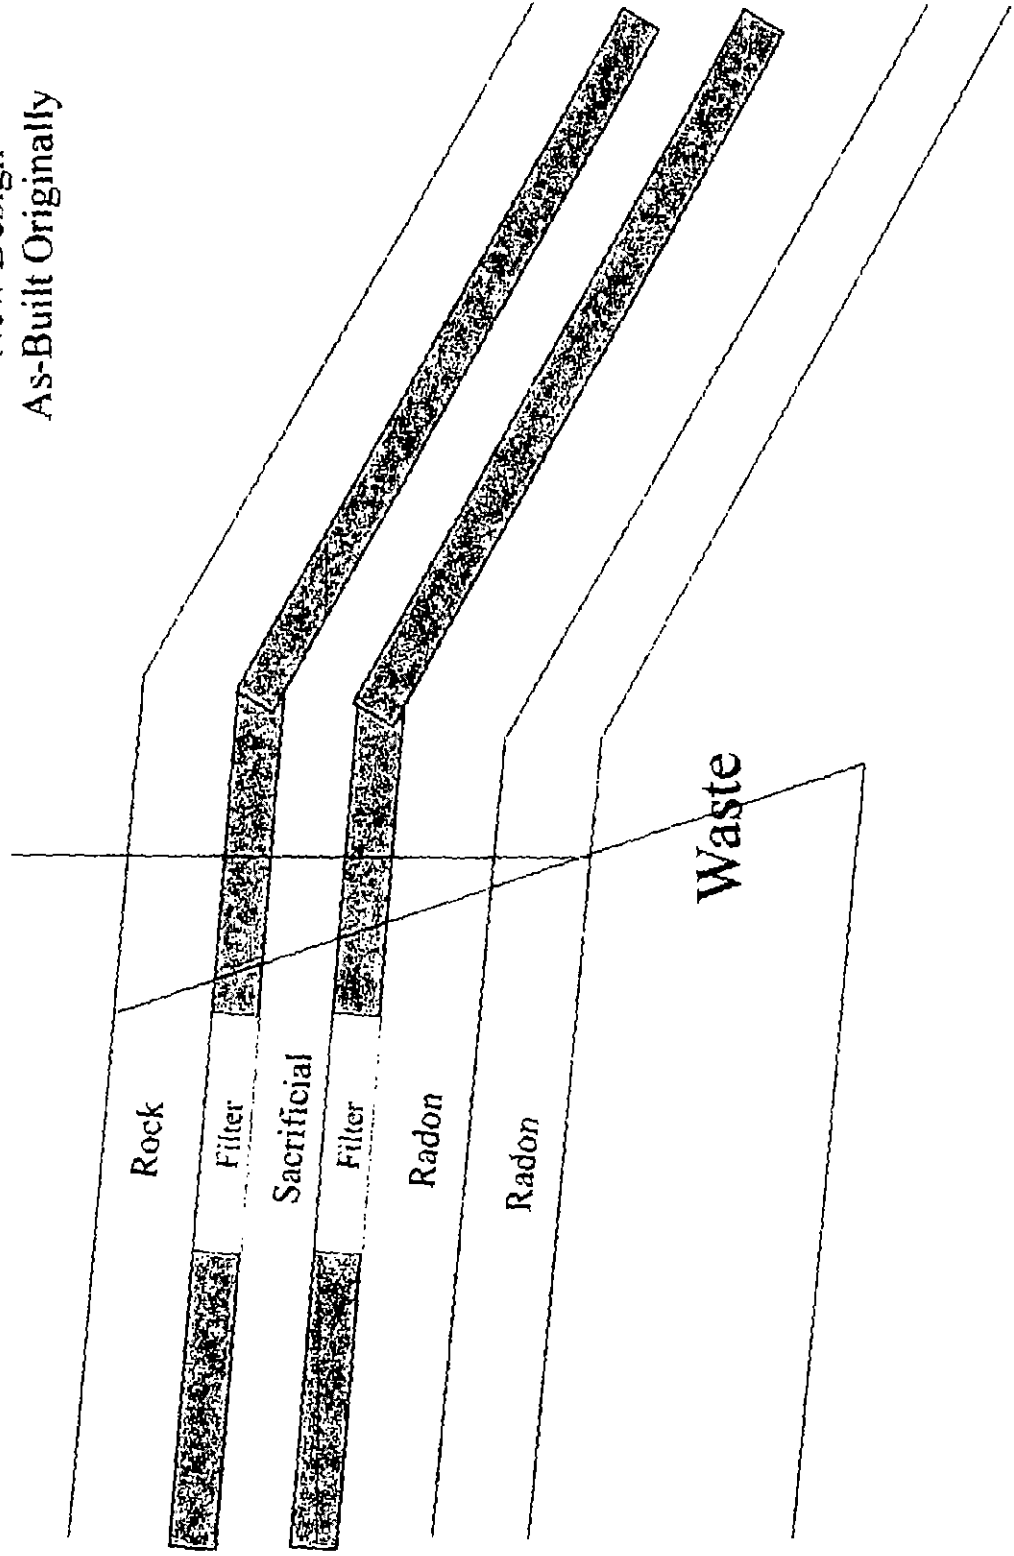
Attachment 7-4

New Design  
As-Built Originally

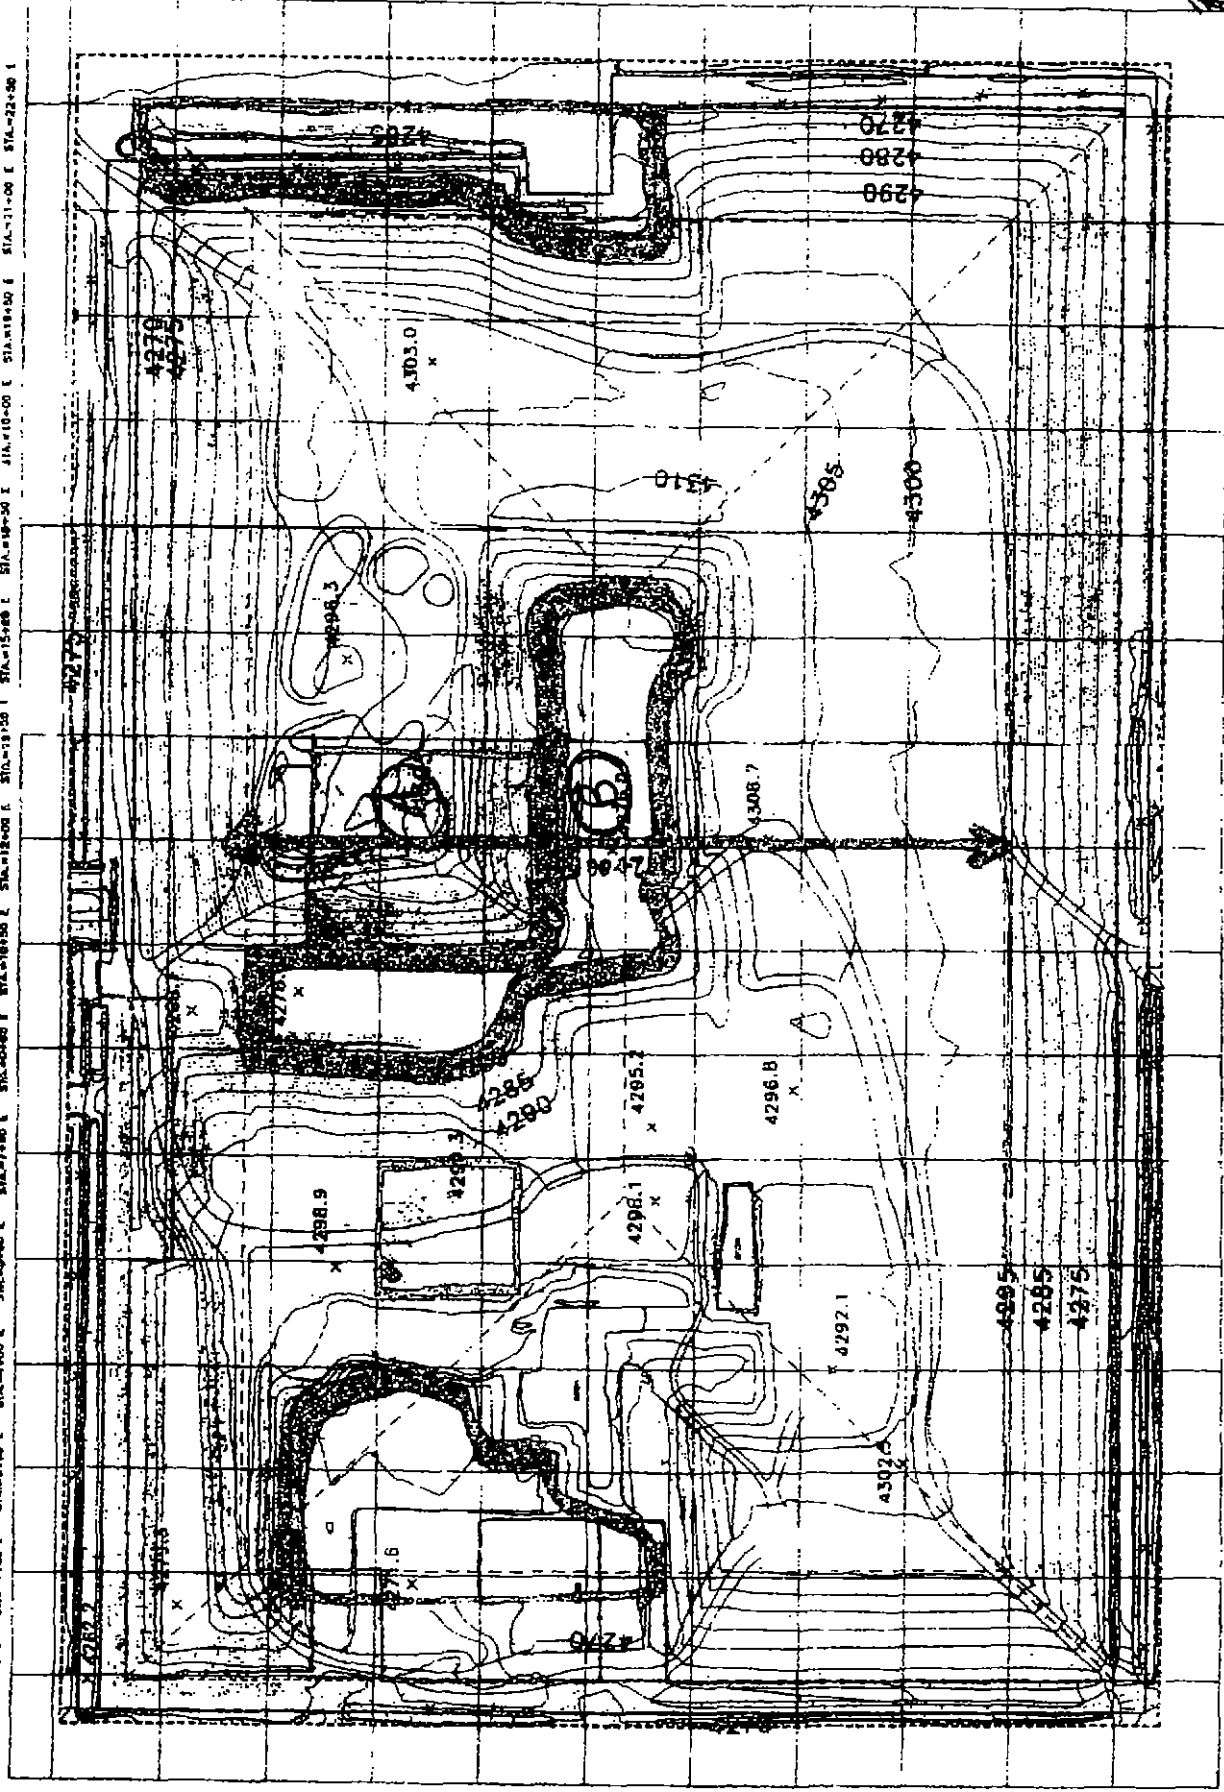
CLASS A EMBANKMENT  
100 50 0 100 200

considers possible effects of having a section of the embankment completed to cover height with an adjacent area of waste placement less than 25 feet high. ... The low height of 25 feet was chosen because this is the maximum calculated height of the embankment before preconsolidation stress is exceeded; in excess of this thickness, primary consolidation (settlement) begins to occur in the lowest layers of the embankment. This condition represents the maximum potential differential settlement for the liner." In other words the maximum difference in between areas where waste can be placed is 25 feet. Instead, Energy Solutions has constructed the cell with areas where the difference in heights of adjacent waste sections is 38 feet. (See Attachment 7-6 (red areas)).

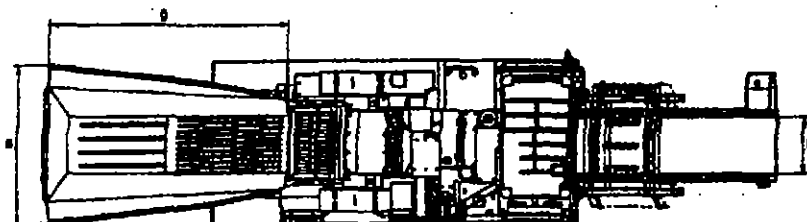
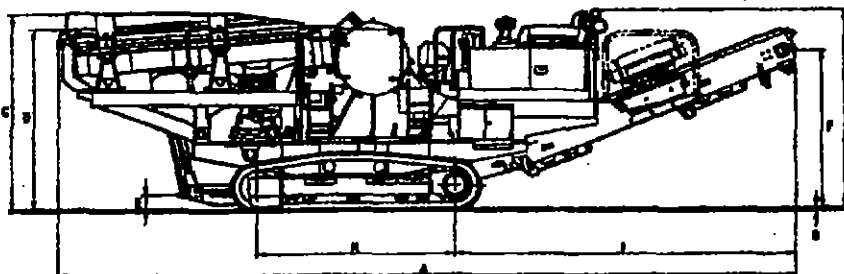
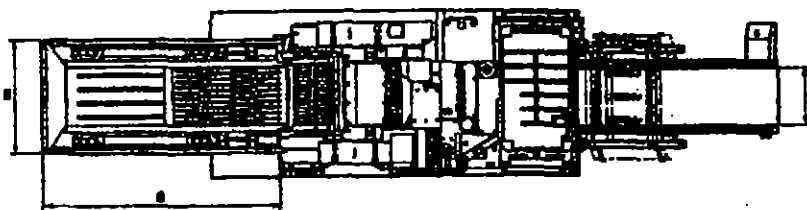
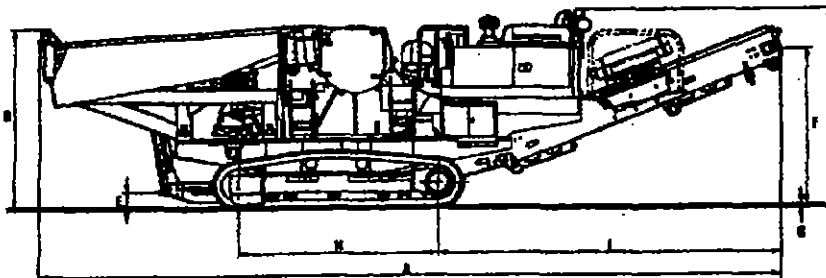
## DIMENSIONS

A	Overall length	13430 mm	44'1"
B	Overall height	3640 mm	11'11"
C	Feed height—side	3640 mm	11'11"
D	Feed height—rear	3365 mm	11'0"
E	Minimum ground clearance (during travel)	350 mm	1'2"
F	Discharge height	3000 mm	9'10"
G	Track thickness	30 mm	1"
H	Length of track on ground	3700 mm	12'2"
I	Discharge from idler center	6145 mm	20'2"

J	Overall width	3115 mm	10'3"
K	Track gauge	2480 mm	8'2"
L	Track width	2980 mm	9'9"
M	Shoe width	500 mm	19.7"
N	Hopper width	2805 mm	9'2"
	Hopper width when folded	2130 mm	7'0"
O	Hopper length	4365 mm	14'4"
P	Discharge conveyor belt width	1050 mm	42"

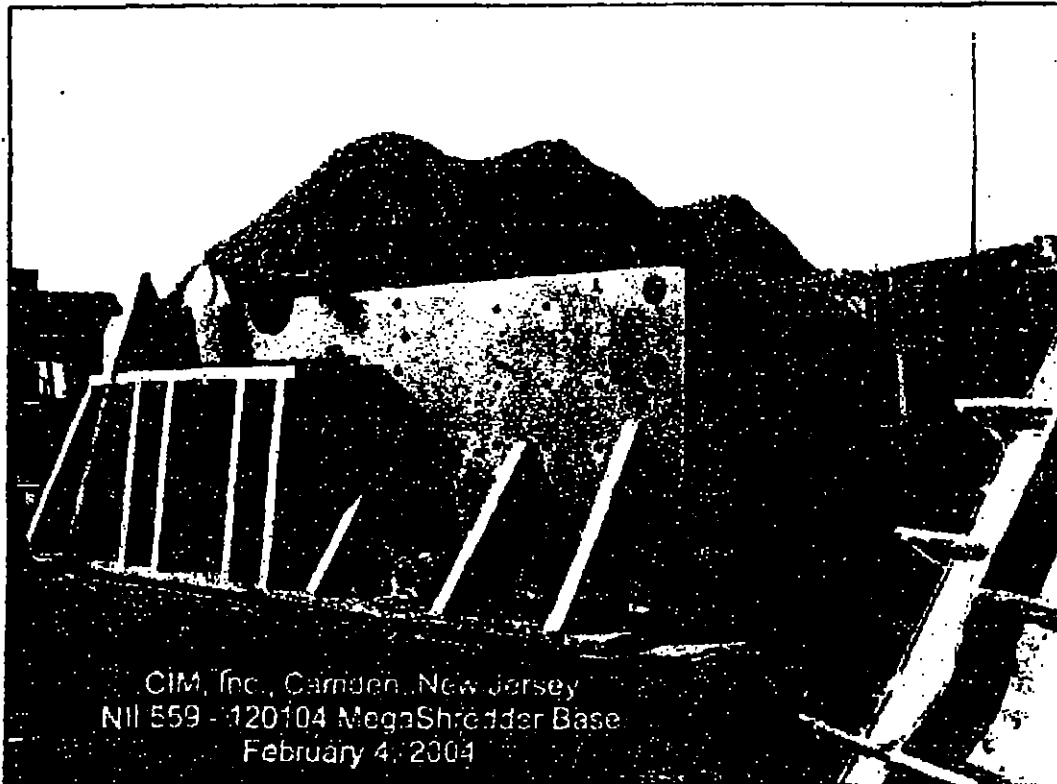
CIM, Inc., Camden, New Jersey  
NII 559 - 120104 MegaShredder Base  
February 4, 2004

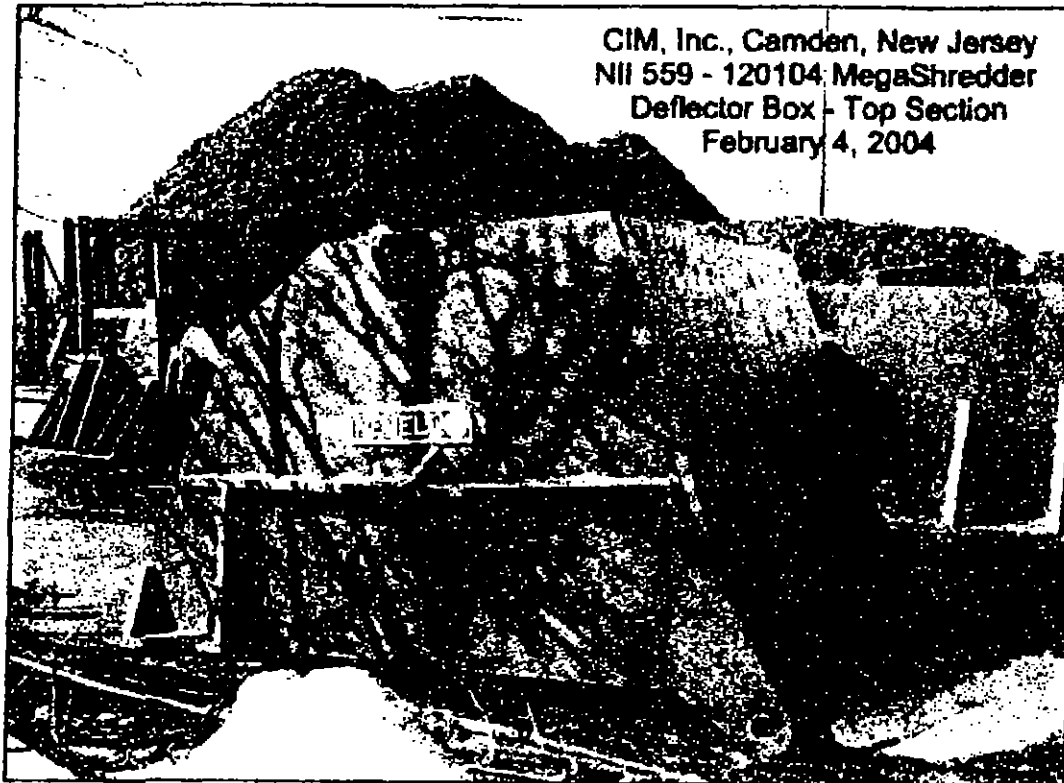
CIM, Inc., Camden, New Jersey  
NII 559 - 120104 MegaShredder  
Deflector Box - Top Section  
February 4, 2004

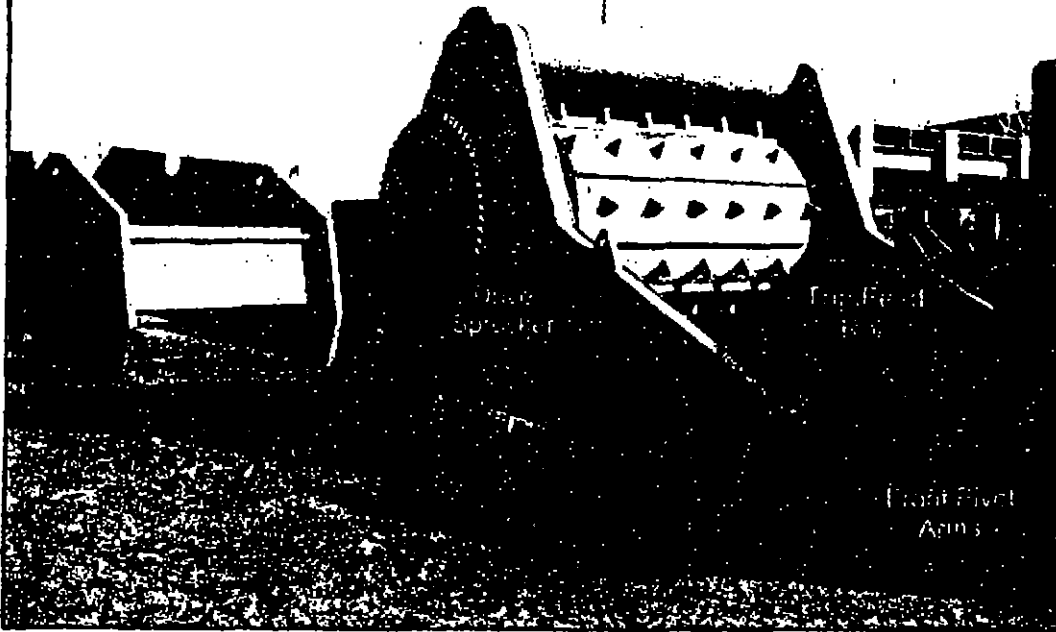
CIM, Inc., Camden, New Jersey  
 NII 559 - 120104 MegaShredder Feed Chute Support  
 February 4, 2004

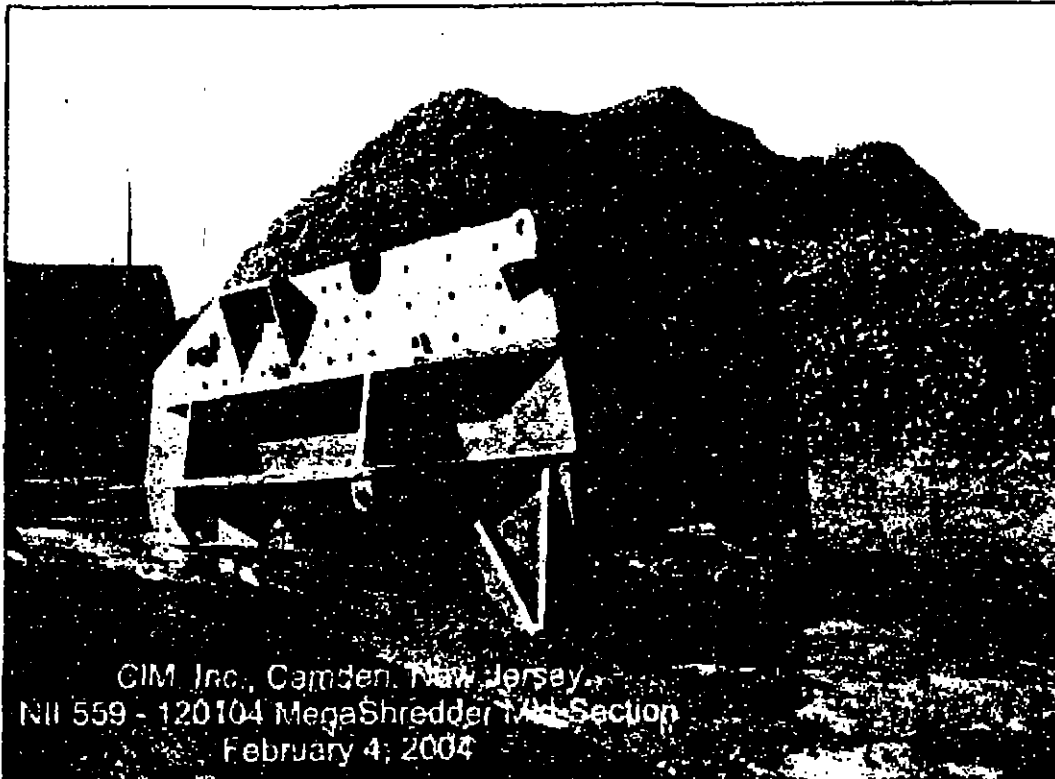
CIM, Inc., Camden, New Jersey  
NII 559 - 120104 MegaShredder Mid-Section  
February 4, 2004

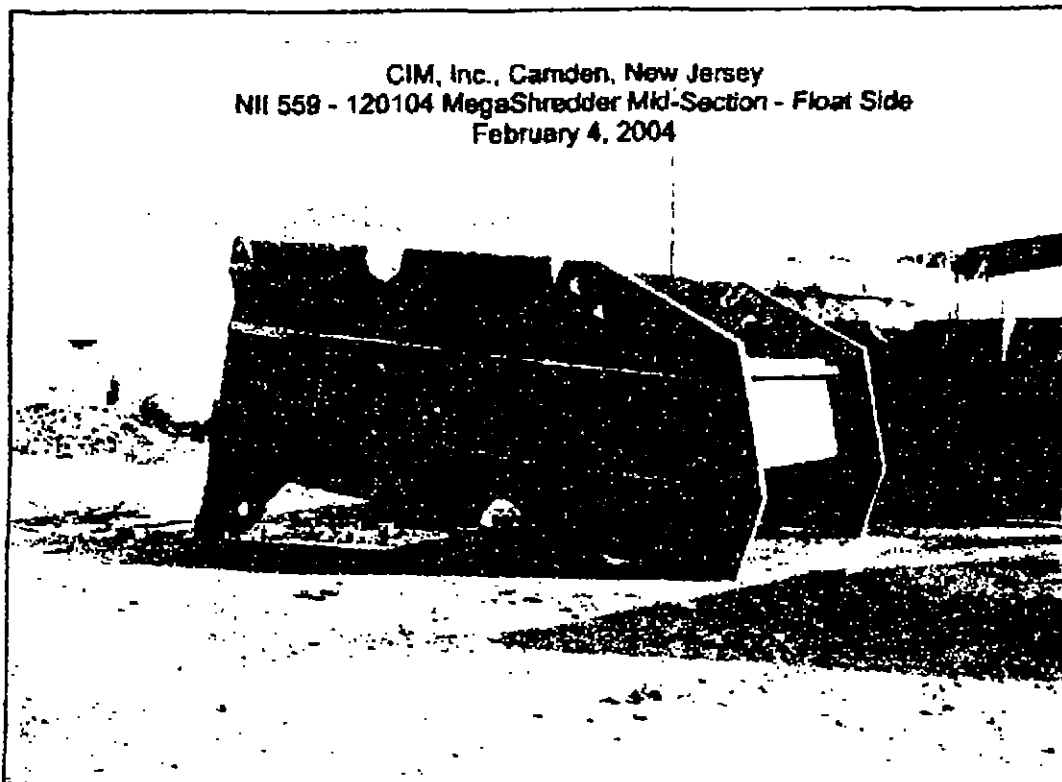
CIM, Inc., Camden, New Jersey  
NII 559 - 120104 MegaShredder Mid-Section - Float Side  
February 4, 2004

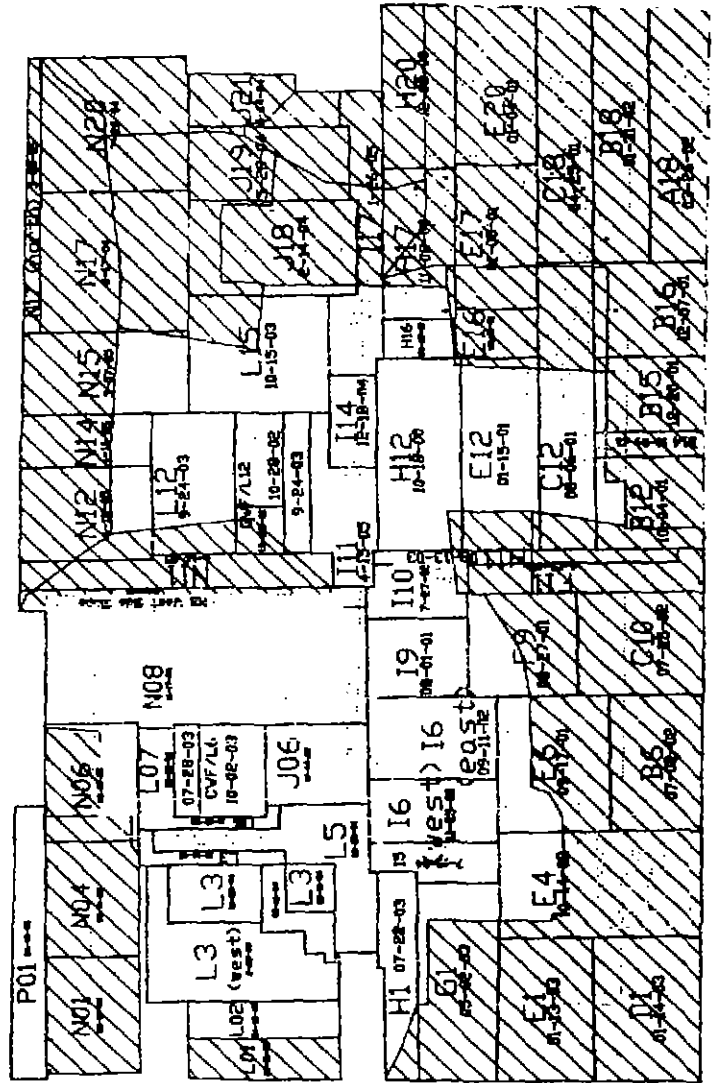
Attachment 7-8

Temporary  
Cover  
1,742,920 sf
